iMAST

Institute for Manufacturing and Sustainment Technologies

Ceramic Thermal Spray Coatings for Improved Wear Resistance and Life-Cycle for Submerged Materials and Mechanical Systems

New VLS Sealing Surface Method Repair a Success

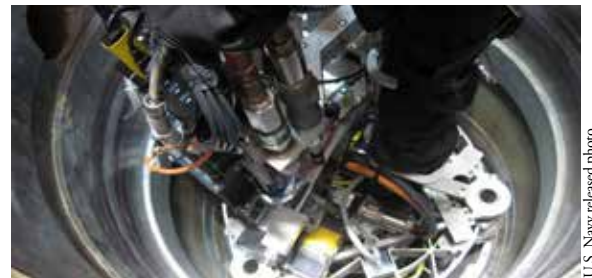
View of tube with laser clad weld module installed.

The VLS sealing surface repair method uses a laser welding machine that performs three tasks. The first is to grind the inside of the missile tube down until the inner part is smooth all the way around. The grinding smooths out pot marks, scratches, corrosion and other defects that accumulate during the wear and tear of being underway. The second part of the process is laser welding corrosion resistant steel to the now smooth tube. The final piece is to grind the tube down to its original specifications.

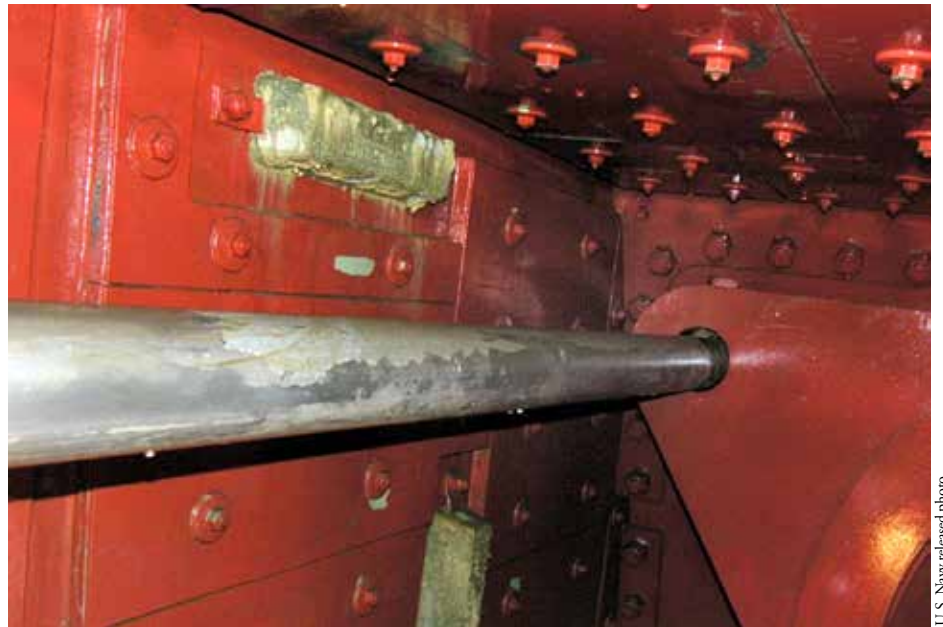
Figure 1. Photo showing calcareous deposits on a submerged uncoated extend/retract cylinder rod.

In the case of wetted hydraulic actuators, the failure of the protective coating preceded seal, and shortly thereafter, actuator failure. When these seals fail, their replacement, depending on the application, may require either an unplanned dry-docking or installation of cofferdams. The primary failure mode on submerged components has been attributed to the build-up of calcareous deposits, such as that shown in Figure 1. The components which are the primary focus for this project are fabricated from Monel® K-500 bar and are placed in the cathodic protection system. While the cathodic potential applied to the Monel® K-500 bar inhibited corrosion, the rods at the same time became susceptible to the formation or plating of these calcareous deposits. In order to mitigate the formation and growth of these hard and tenacious

deposits, the addition of an insulating ceramic coating was implemented on a limited basis. During service, however, these coatings demonstrated a tendency to delaminate and spall from the Monel® K-500 bars, thus allowing the calcareous deposits to form on the now bare metal, leading to seal damage and ultimately system failure. If these insulating ceramic coatings can be deposited reliably, uniformly, and with improved adhesion, the insulating nature of the ceramic coating would prevent the formation of calcareous deposits and mitigate the accelerated seal degradation observed in service.

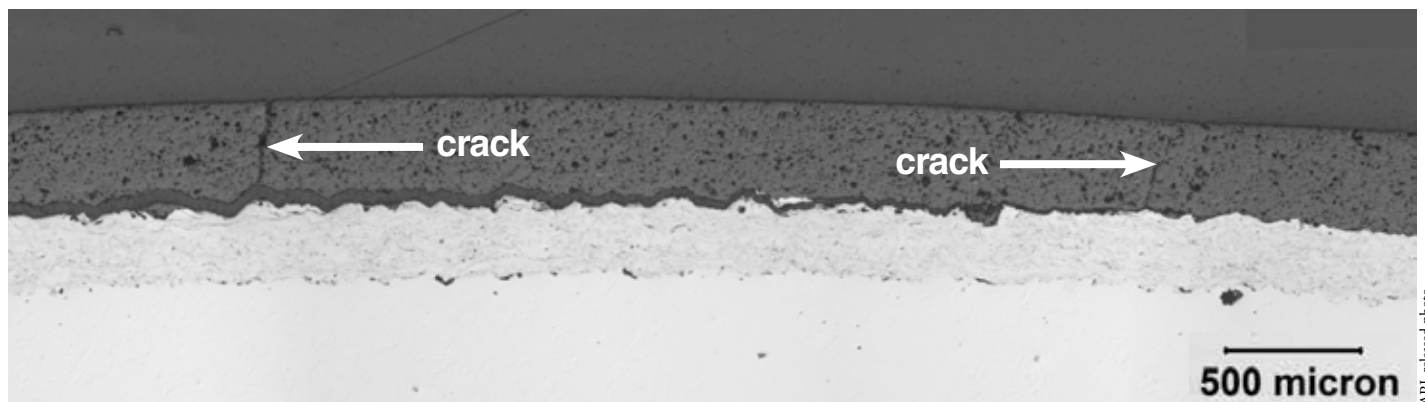
Figure 2. Stitched optical micrographs showing cracking between the ceramic topcoat and the metallic bond coat which resulted in poor adhesion. Also evident in the micrograph is the high volume fraction of porosity, which can limit coating mechanical properties.

Further analysis showed cracking between the ceramic topcoat and the metallic bond coating as well as a non-uniform and thick oxide layer at the interface at times, both of which lead to very low coating adhesion. Additional analysis of the metallic bond coating showed horizontal cracking within the metallic bond coat which indicated increased brittleness which usually results in lower coating adhesion. Careful investigation of the bond coating showed non-uniform bond coat thickness and microstructure including variation in the substrate/bond coat surface roughness and in some cases, no bond coating at all. Each of these issues can lead to variability in the coating adhesion strength, leading to the coating delamination issues observed in service. Therefore, a systematic approach was pursued by the ARL-led team to optimize the coating adhesion and microstructure.

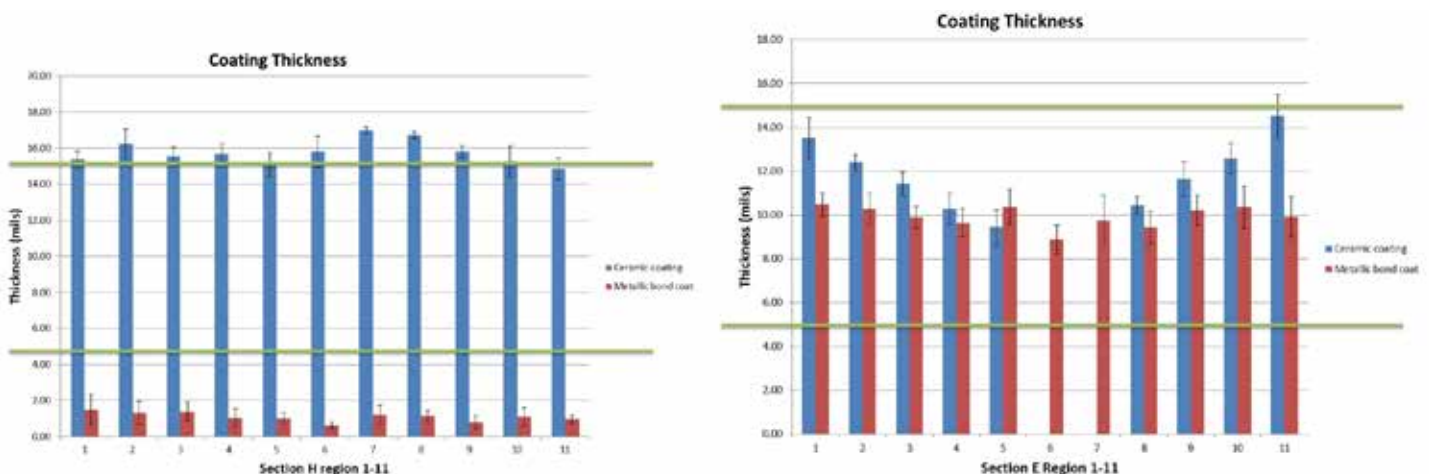
Figure 3. Ceramic coating and metallic coating thickness plotted as a function of circumference along the outer diameter of the RBP showing (left) bond coating thickness out of design specification and (rod) non-uniform coating thickness resulting from poor thermal spray manufacturing process control, and also coating delamination.

Figure 3 shows a coating thickness profile graph along the shaft diameter in which the coating did not meet the minimum thickness specification and displayed substantial local thickness variations in both the ceramic topcoat and the metallic bond coat. In some localized areas, no bond coating was observed which is catastrophic for ceramic coating adhesion. These coating thickness variations along the rod length and circumference led to variations in the coating durability due to differences in the coating microstructure.

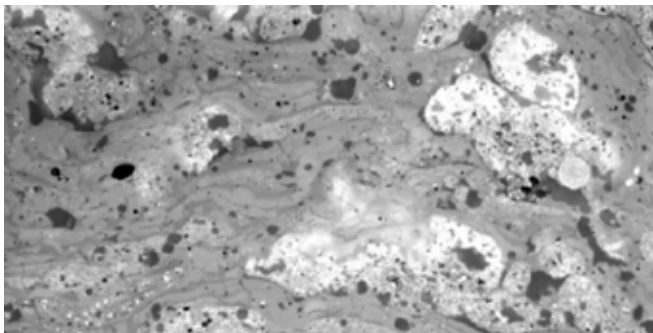
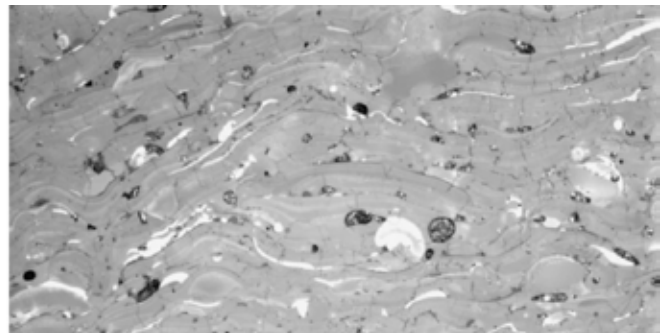
Figure 4. Scanning electron microscopy (SEM) images of the polished cross sections of ceramic topcoat deposited by Air Plasma Spray coating process showing (left) unoptimized and (right) improved coating manufacturing conditions in which coating density was increased and porosity reduced. (ARL released photo)

The team used a suite of analytical characterization equipment within the materials characterization laboratory at Penn State in order to map out the processing window including X-ray diffraction, scanning electron microscopy, energy dispersive spectroscopy, optical profilometry, and mechanical testing. Improved coating density was realized with optimized atmospheric thermal spray coating deposition processing parameters as shown by the scanning electron microscopy images of the polished cross sections of the ceramic topcoat in Figure 4.

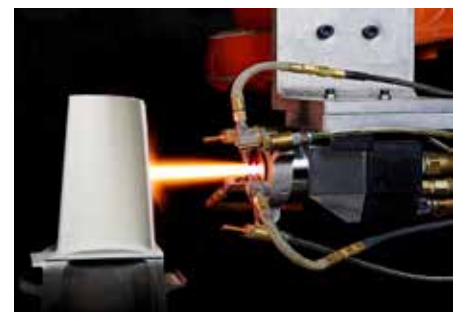
Thermal Spray Coating application. (ARL released photo)
